Repair of Concrete Blocks. Clifton Surf Club

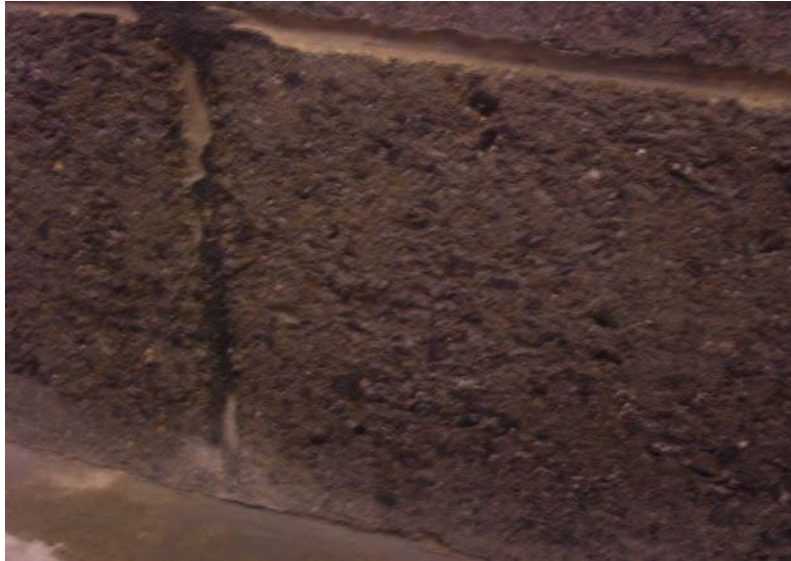
As the ground underneath the footings was sandy, wet most of the time and full of salts it was a recipe for disaster.

Figure 1 – Deterioration of Block Wall.

Predictably the salty water rose up through the footings and then through the blocks and where the water evaporated there was strong efflorescence, pitting, loss of material and damage.

The TecEco solution was to make up a formulation of eco-cement mortar which we doctored with some special chemicals to prevent the rise of any more moisture and salt.

The solution worked well and appears to have stopped the problem.

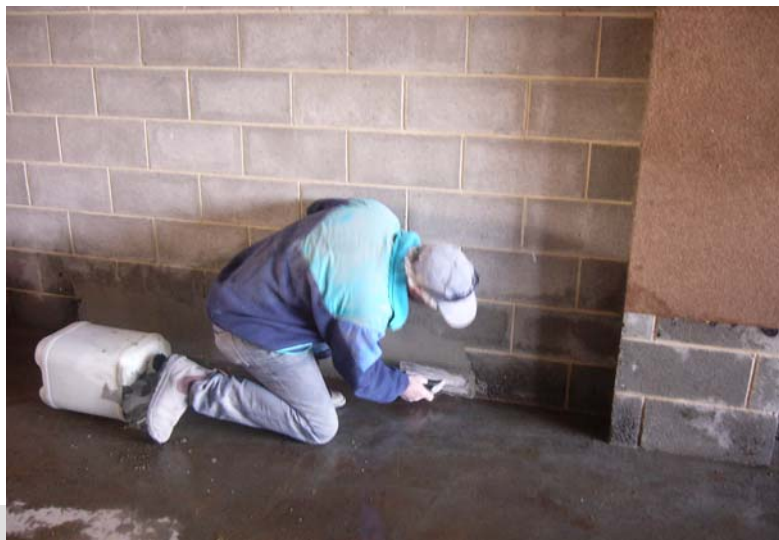
Figure 2 - Applying the Eco-Cement Mortar
